## The Impact on Runoff Behavior Due to the Establishment of Photo-Voltaic Facilities by Geoteva Environmental Consultants

March, 2020

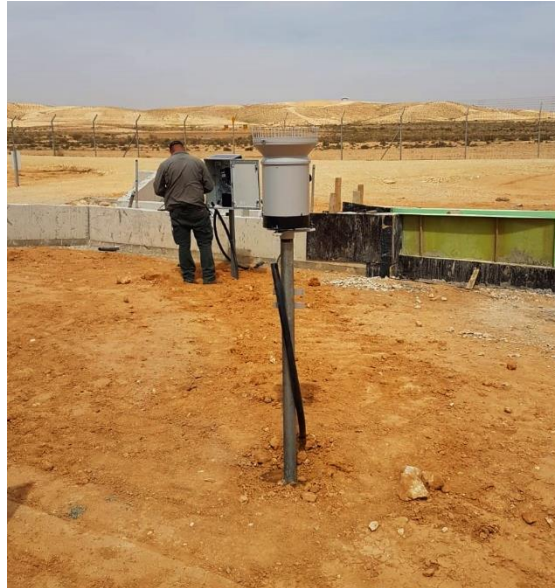
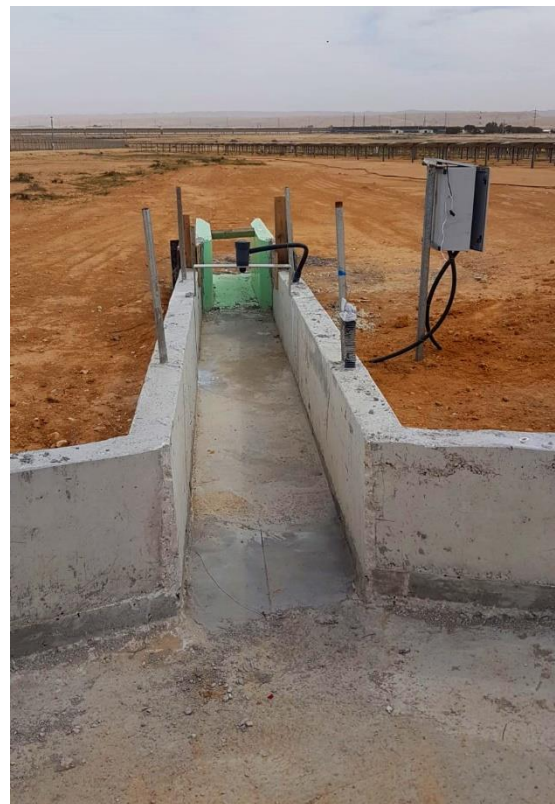
To further explore this phenomena, Geo Teva Environmental Consultants and Yamma Hydrometric Solutions built a Hydrometric Monitoring Station at the Ashalim PV site, belonging to EDF-RE. This site will monitor the flow of runoff from the drainage basin in the 50-dunum PV facility throughout the project site.

For this project, an artificial channel was built to funnel the flow of water through a "AquaLabo AV1500" sampling system, utilizing an Ultrasonic Sensor (a product of Ayyeka Technologies) to measure flow levels and rain quantities. This monitoring station will enable the assessment of the impact of the PV facility on the properties and behavior of runoff waters throughout the project site.
